AVIATION OCCURRENCE REPORT

PACIFIC WESTERN AIRLINES LTD.
BOEING 737-200 C-GQPW
CALGARY INTERNATIONAL AIRPORT
CALGARY, ALBERTA
22 MARCH 1984

REPORT NUMBER 84-H40003

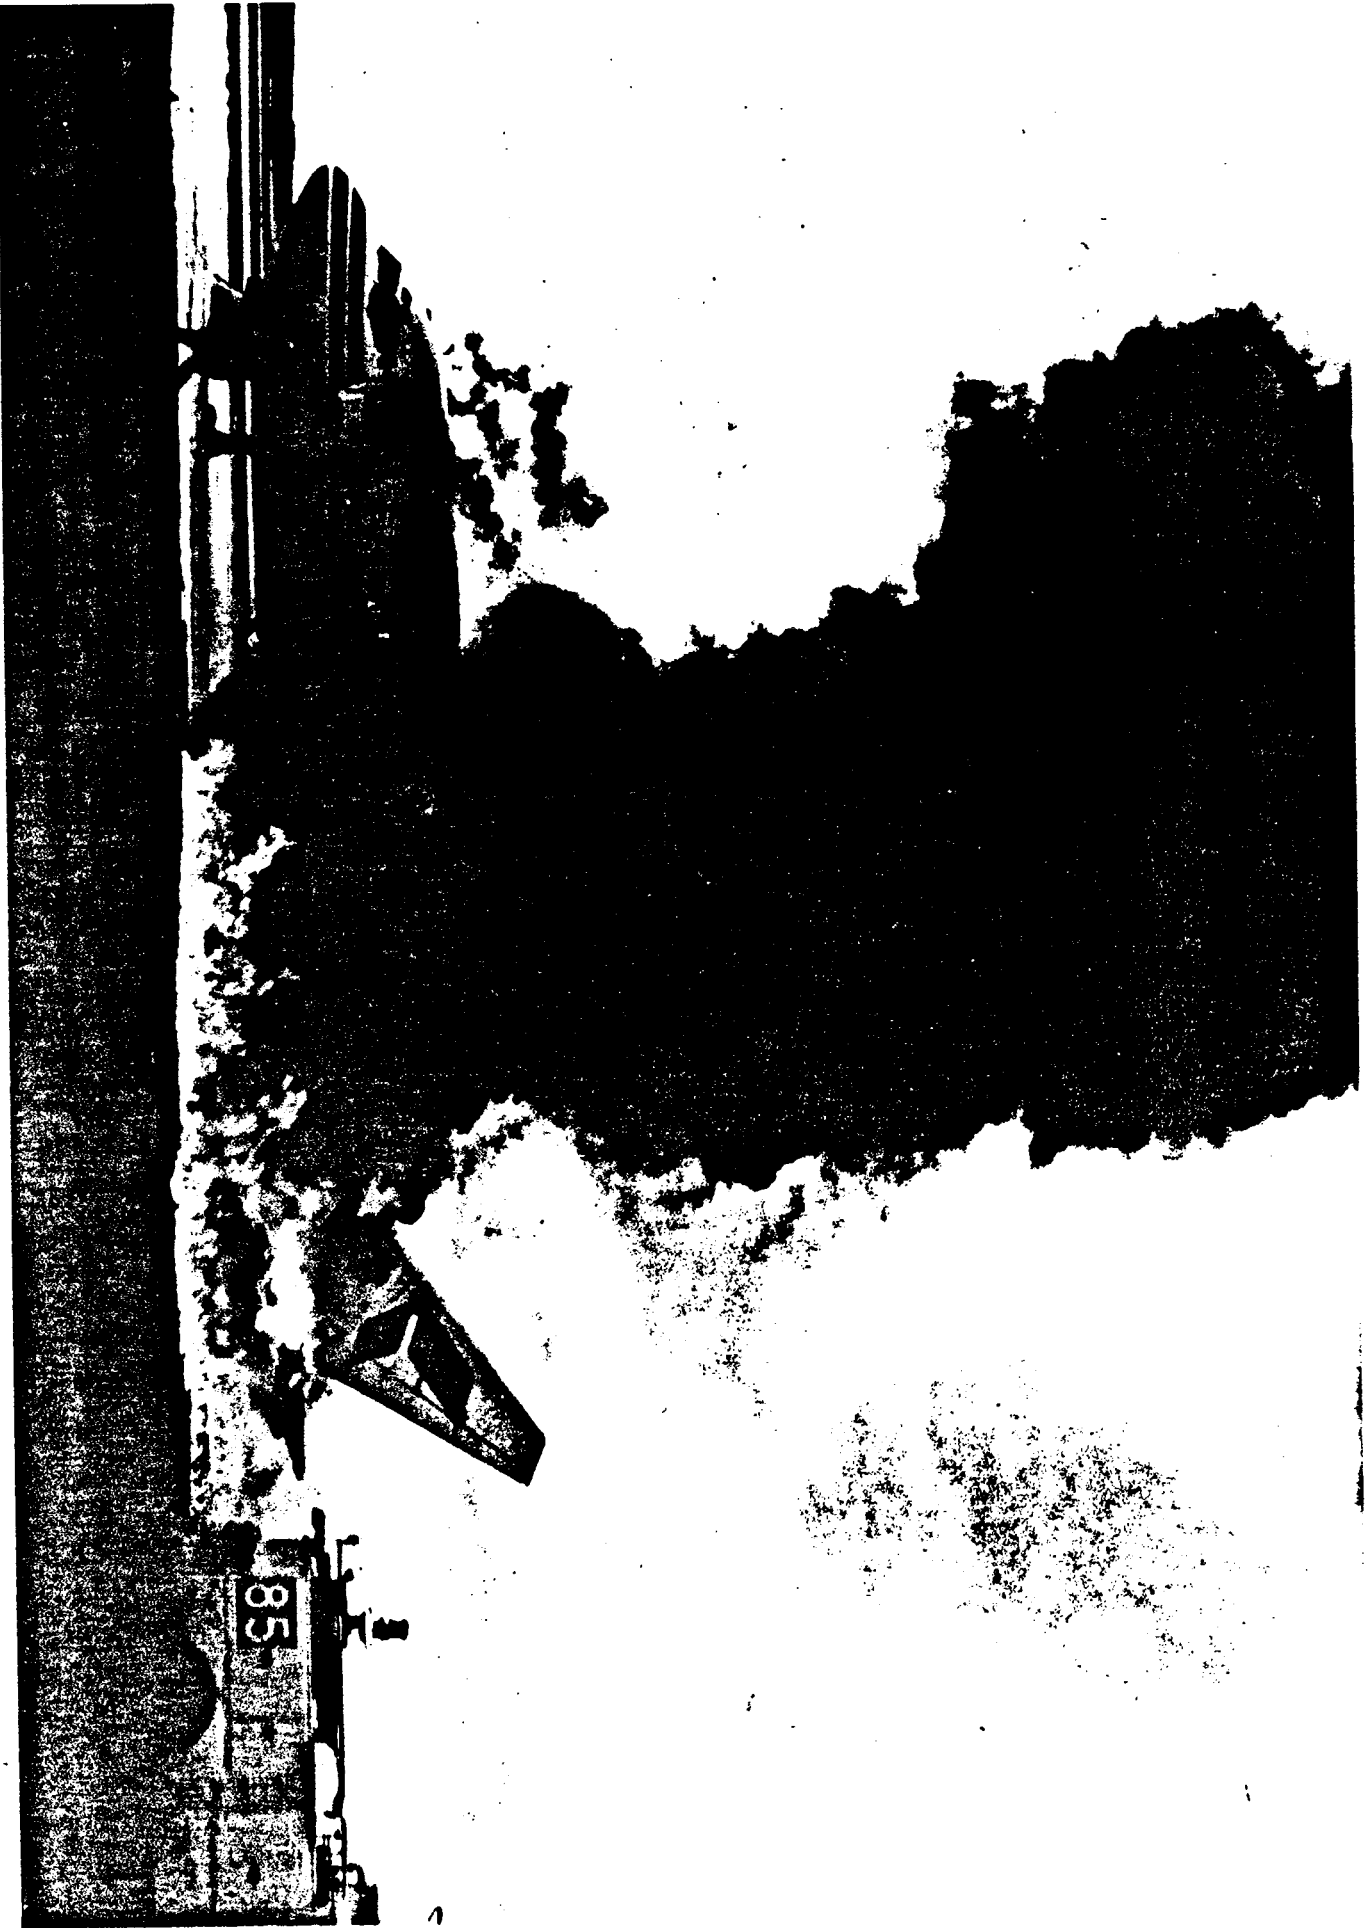
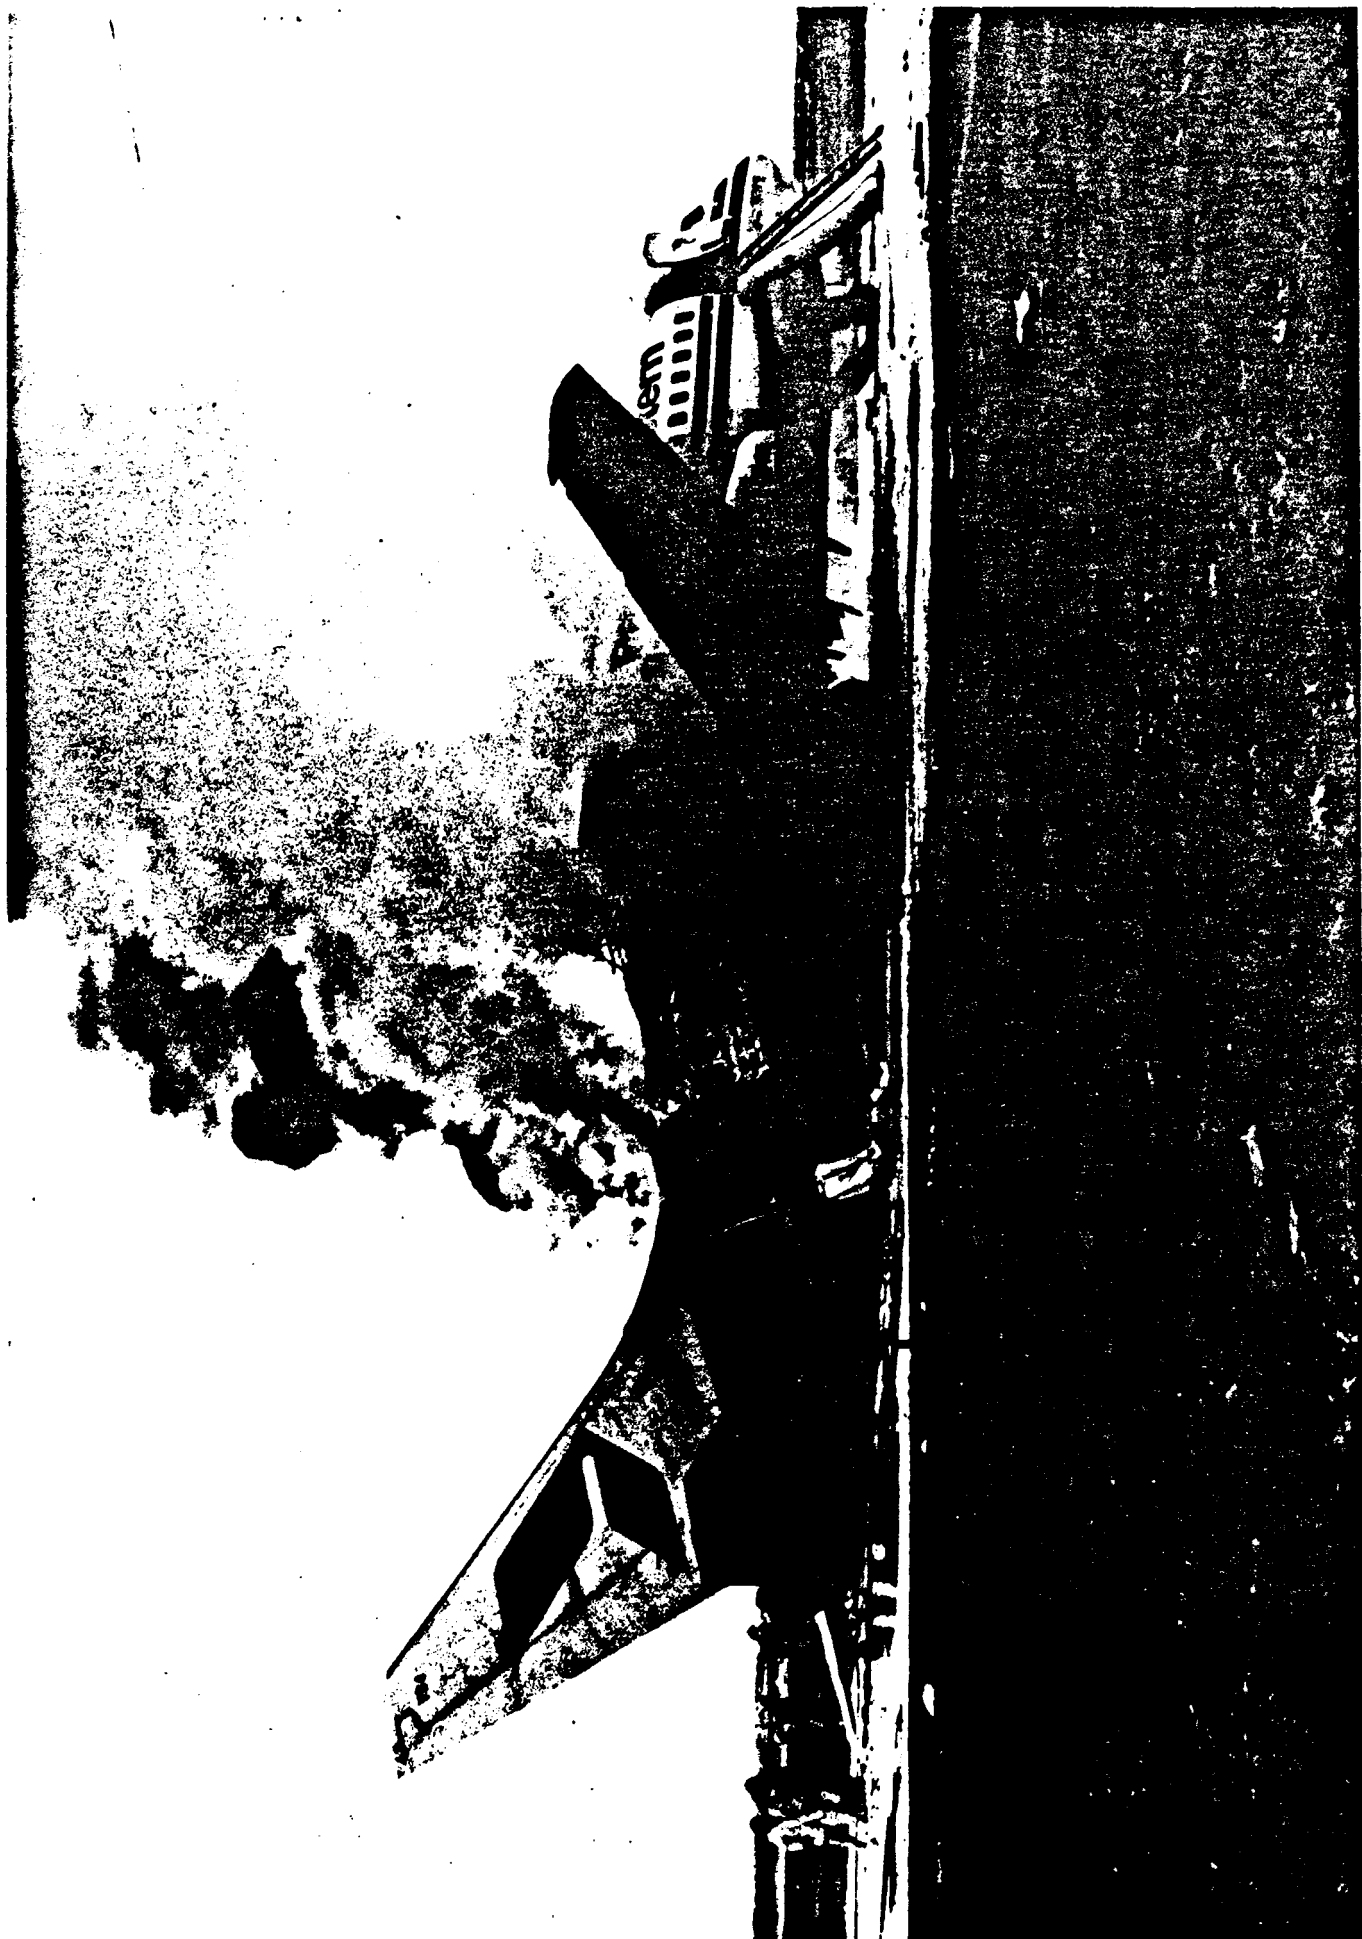
LEFT VIEW OF AIRCRAFT

The left side of the fuselage sustained smoke and heat damage extending from fuselage station 450 to station 1064 (See Appendix D). The fuselage had fractured at station 747 and a large section above the window line between stations 747 and 890 was burned away. The right side of the fuselage sustained smoke and heat damage of a lesser nature between stations 480 and 1010.

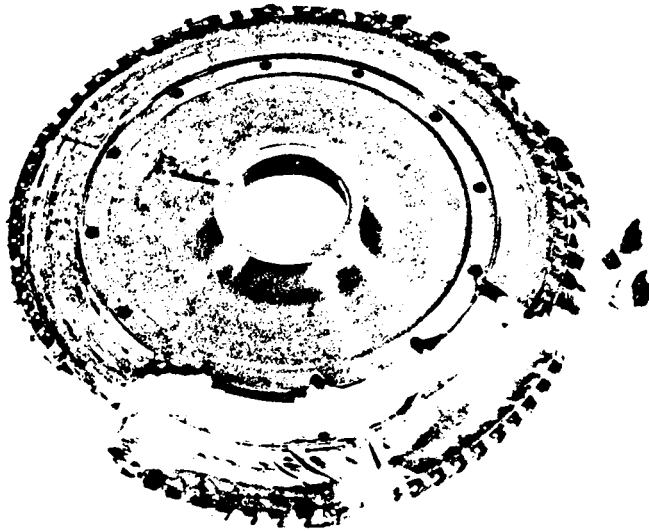
Initial examination of the failed disc at the CASB Engineering Laboratory determined that the disc failure had occurred through the release of a 20-blade segment of the rim outboard of the rear snap between tie-bolt holes 7 and 10 (See Appendix E, Figures 1 and 2). The snap is commonly referred to by the manufacturer as the machined surface which forms the mating point between the disc and adjacent engine components. Continuity of scrape and other markings across the two fragments indicated that the sections had separated in a single piece and had broken in two during penetration through the engine containment. Examination determined the presence of half-moon-shaped fatigue cracks (See Appendix F, Figures 3 and 4, Appendix G, Figures 5 and 6) emanating from the snap radius on the rear face of the disc which were approximately equal in size and were characterized by well-defined crack progression markings typical of a fatigue mode of formation. Further laboratory examination of the remainder of the rear snap disclosed another circumferential fatigue crack (See Appendix H, Figure 7) which was exposed and found to exhibit a similar failure mode to the crack surfaces of the released rim. Fatigue cracking was also identified at 6 of the 12 tie-bolt holes.

Figure 1 - 13th stage compressor disc, p/n 717313H, s/n J60916, as received, front face.

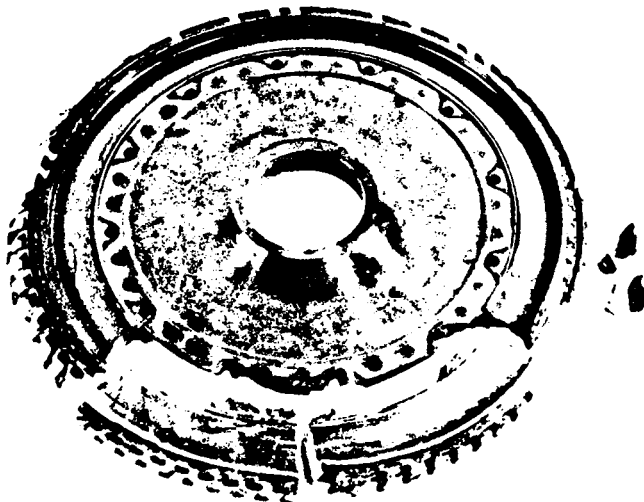
The fatigue cracks were examined extensively for possible causes of initiation. Examination of the region of origin in the rear snap disclosed the existence of a feedline, resulting from the failure of the radius to blend smoothly with the rear face of the disc. The location of this feedline was coincident with the position of crack initiation. Further examination determined that the feedline resulted in a snap radius dimension that did not fully conform to blueprint requirements.

Figure 2 - 13th stage compressor disc, p/n 717313H, s/n J60616, as received, rear face.

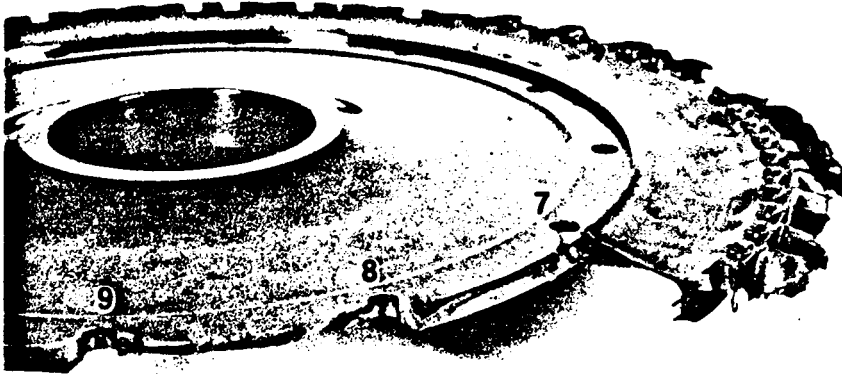
Figure 3 - 13th stage compressor disc, crack A, fatigue crack between tie bolt holes No. 7 and No. 8.

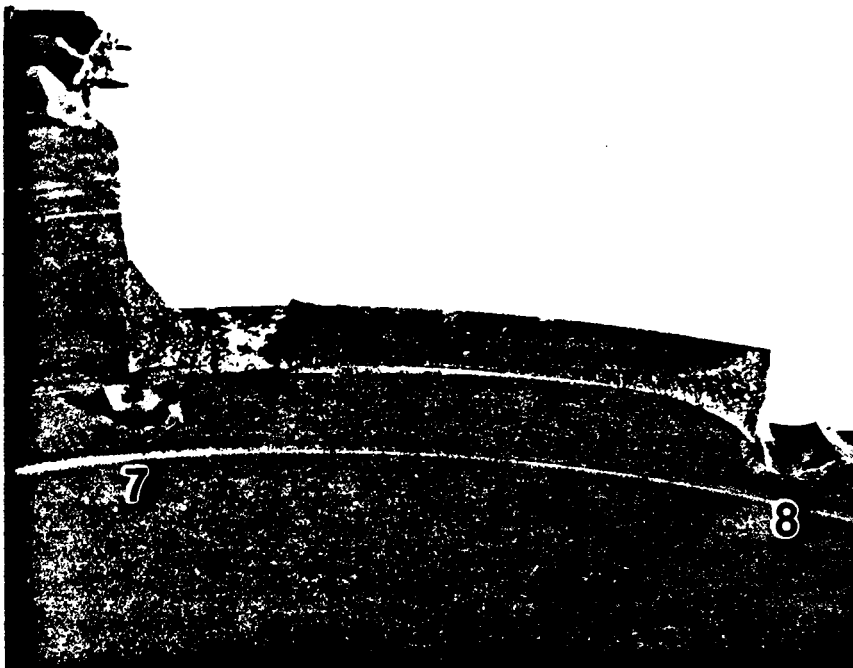
Figure 4 - 13th stage compressor disc, showing location of crack A.

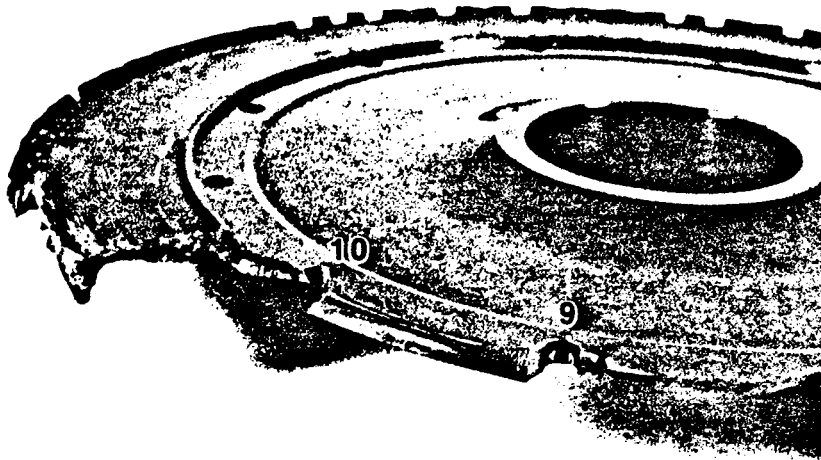
Figure 5 - 13th stage compressor disc, crack B, fatigue crack between tie bolt holes No. 9 and No. 10.

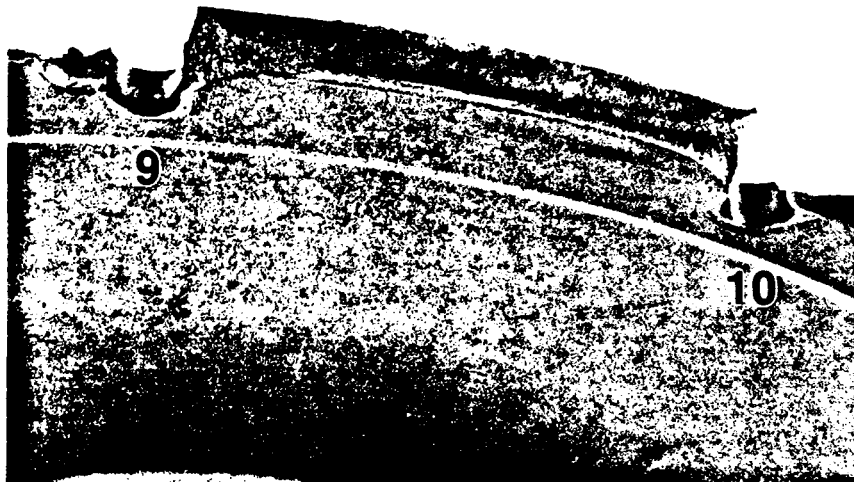
Figure 6 - 13th stage compressor disc, showing location of crack B.
